SPADIC status and plans

CBM Collaboration Meeting
22.04.2015, GSI

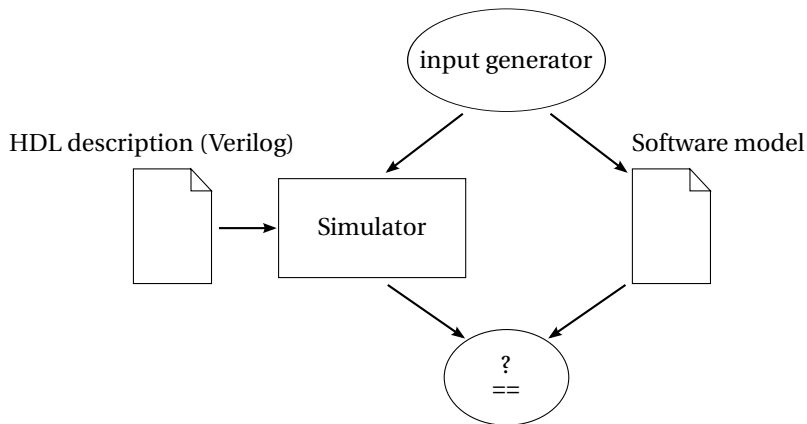
Step 1: create software model and adjust it until it exactly reproduces the behaviour of the original SPADIC 1.0 hit detector (mostly trial-and-error)

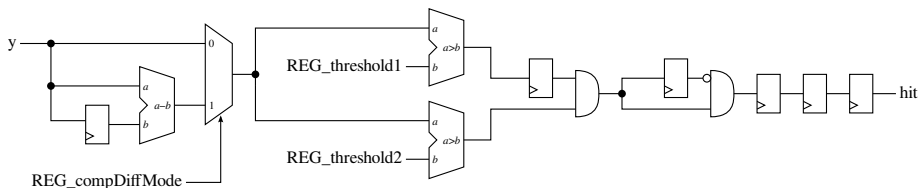
New hit detector

- 1 subtractor, 1 multiplexer, 2 comparators (9-bit)
- 2 AND-gates, 1 inverter
- 14 registers (9 + 1 + 1 + 3)
- delay of 3 clock cycles at output only for compatibility (can be removed in SPADIC 2.0, possibly also simplifying other logic)

SPADIC 1.0 hit detector	SPADIC 1.1 hit detector
No. of clocks	2	1
Lines of code	280	70
No. of registers	45	14
No. of logic gates	≈ 240	≈ 140
Silicon area	$\approx 9000\mu\text{m}^2$	$\approx 4500\mu\text{m}^2$
Draw accurate picture	hard	easy
